# RUSSIAN MISSION HEALTH CLINIC

## Alaska Rural Primary Care Facility Code and Condition Survey

Final  
July 23, 2001

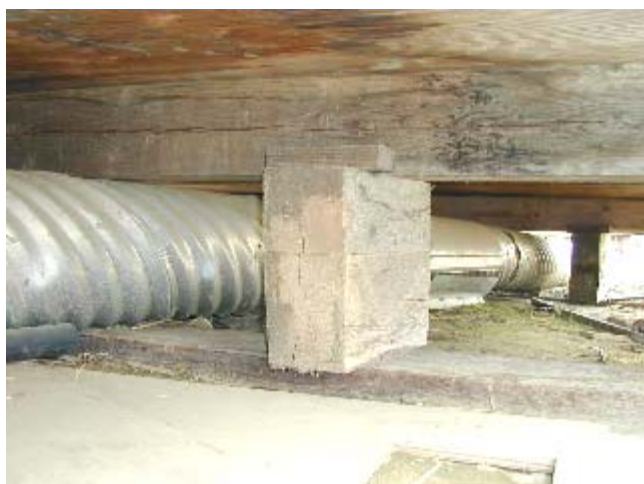
The foundation is 8 x 8 " post and pad over a silty, sandy dirt base and is in poor structural condition. Pads have settled, walls are racked, and the building has floor level deviation and has substantial cracking on the interior. There is no hold down strapping and the bracing is loose or missing. In general the foundation needs substantial upgrade work for a new useful lifetime or replacement.

**Foundation and water line**

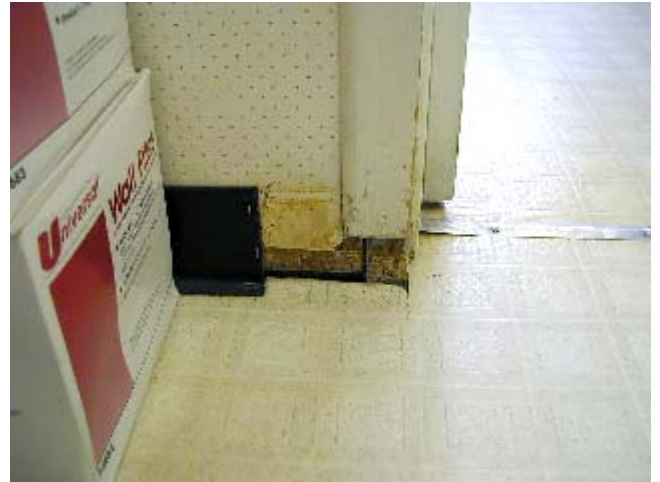
This is being completed with minimal long-term control due to lack of facilities. Floor materials are very worn out and replaced with multiple materials and sizes allowing for control problems. There is no rubber base material, and walls is mostly of plywood covered with wallpaper that is deteriorating and ceiling materials are old acoustic ceilings are also considerably lacking in cleaning ability. The exposed heat piping also provides very unsanitary conditions and impossible cleaning of the exam rooms. There is neither janitor sink for general cleaning nor sinks in the exam rooms for practioner use.

**Un-sanitary floor, wall and base.**

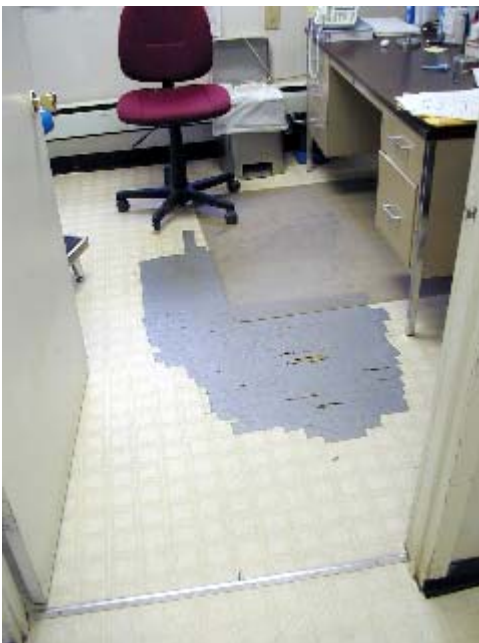
- a. Flooring:  
The flooring is Sheet vinyl over plywood. It has been replaced in many areas and is seriously deteriorated in most areas. Duct tape has been used to patch the flooring that is worn out and covered with duct-tape in other areas. Entire replacement of sub-floor and finish is required to meet sanitary requirements.

**Exam room floor, typical**

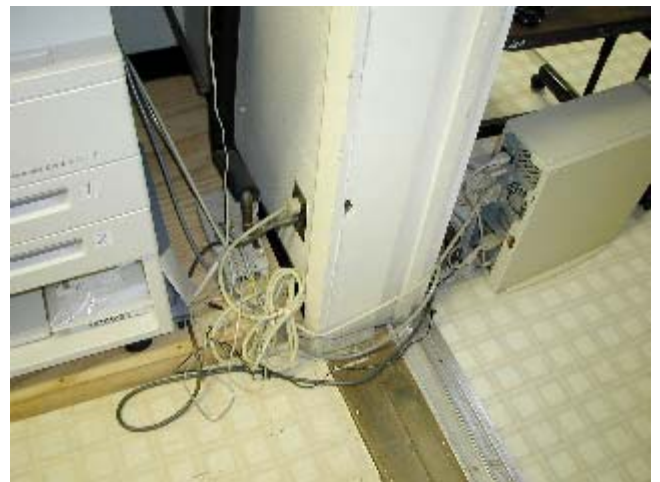
**Typical wiring and floor patching**

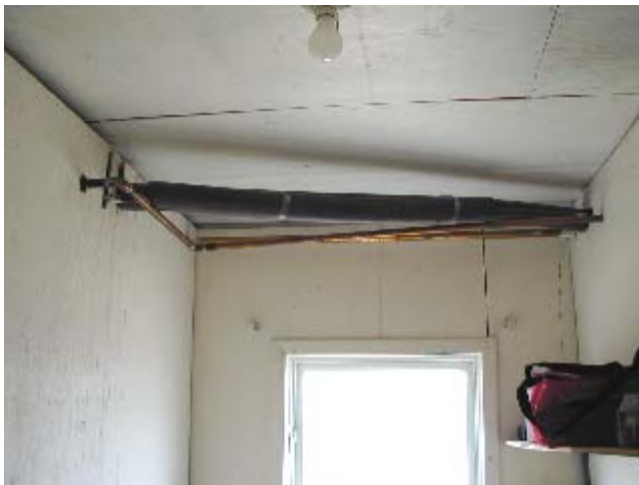
The piping has been routed in the clinic to avoid freezing and is exposed throughout the facility. Pipe insulation has been added which does not meet flame spread and smoke-developed ratings. The baseboard enclosures are all bent and broken. There are active piping leaks in the boiler room and clinic. The entire heating system is in need of replacement.

**Typical piping, Triage, Exam rooms**
